## IRON & STEEL TYPES

## INDEPENDENT PERFORMANCE TESTING

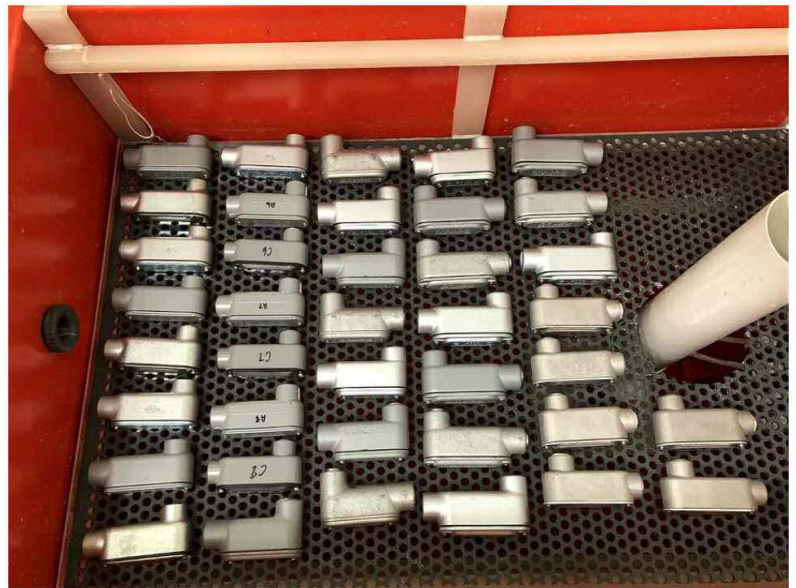
The salt solution used was 5% plus/minus 1% according to ASTM B117-18 "Standard Practice for Operating Salt Spray (Fog) Apparatus." To prevent salt-fog from entering the interior of the conduit body, all iron test samples had steel (zinc-plated) Appleton PLG plugs installed, with aluminum plugs with Teflon™ tape in the aluminum samples. Test samples were subjected to the salt-fog for 1008 hours (42 days), being removed only for inspection and photography at fixed intervals.

All testing was conducted in the Arlington Heights, Illinois (USA) Intertek laboratory in January 2019. Test samples were sorted into 15 groups according to metal and protection types, i.e., iron (plated/painted), die-cast aluminum (painted), cast iron (plated/painted), cast aluminum (unpainted), et cetera. All samples were purchased at electrical distributors straight from their inventory and not sourced direct from the manufacturer. In this paper, we will look at the results from testing various iron and cast iron samples.

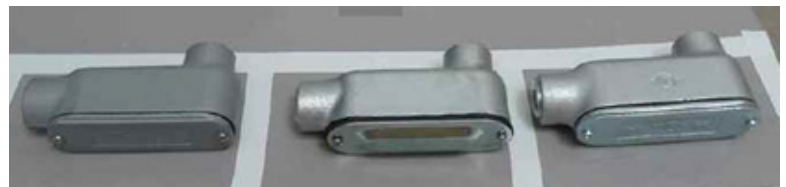
### TEST GROUP #1: IRON

Consisted of three (3) iron conduit bodies protected by:

- Appleton Form 35: Triple cost finish featuring (1) Zinc, (2) Chromate, (3) Electrostatically applied epoxy powder coat
- Competitor A: Zinc plate, Acrylic paint
- Competitor B: Zinc plate, Acrylic paint

Appleton Form 35

Competitor A

Competitor B

Before and after photographs. Above photo are new conduit bodies and below photo shows same conduit bodies after 42 days in salt fog

The test results shown for Appleton Form 35 and FM7 products above are valid only for Appleton's triple coated products. While most Appleton iron products are triple coated, a small number of the products in our lines cannot be triple coated. See an Appleton catalog for more information on the full line of Appleton applications that are triple coated. To learn more, visit [emerson.com](http://emerson.com) to view a full copy of the test report.
